# **INDOOR AIR QUALITY ASSESSMENT**

**Eagle House  
Lunenburg Senior Center  
Memorial Drive  
Lunenburg, Massachusetts**

Prepared by:  
Massachusetts Department of Public Health  
Bureau of Environmental Health Assessment  
Emergency Response/Indoor Air Quality Program  
May 2003

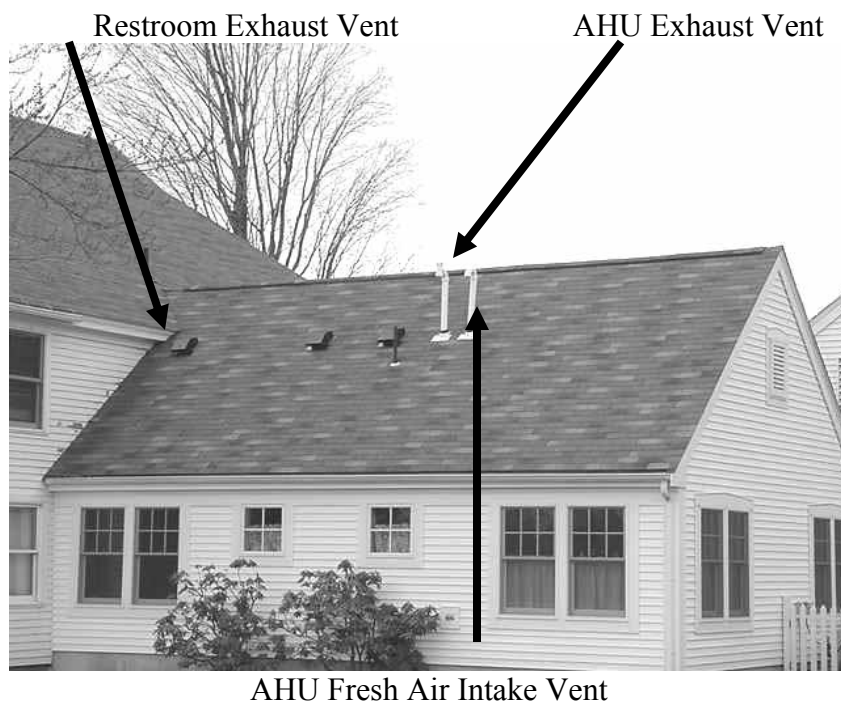
**Picture 1**

Two air handling units (AHUs) provide fresh air for the 1998 wing. The office AHU is located in the attic above the offices. This AHU was deactivated during the assessment. The second AHU is located in the attic above the main function room. Each AHU provides conditioned air by a combination of ceiling and wall-mounted air diffusers connected via ductwork. Air returns to the AHU through ceiling or wall-mounted exhaust grilles via ductwork. Each AHU draws fresh air through a PVC pipe mounted in the roof (see Picture 1). A second PVC pipe serves as the exhaust vent for the AHUs.

**PVC Pipes Mounted in the Roof Serving As Supply and Exhaust Vent**

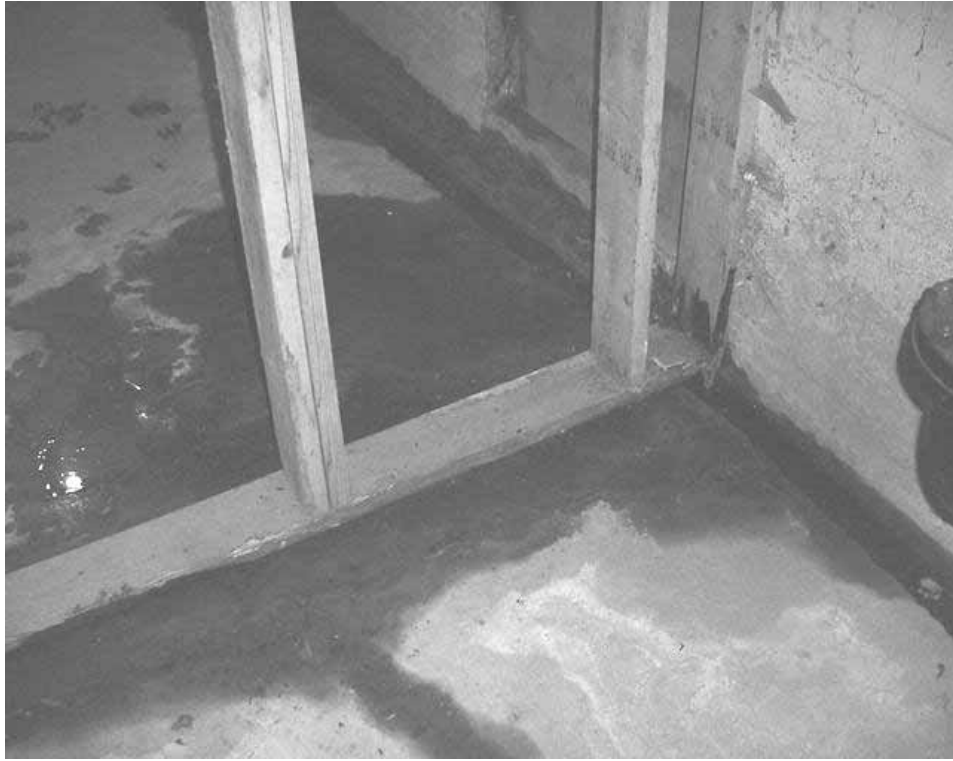
**Picture 2**

The basement along the eastern side of the building showed signs of water penetration. Standing water was noted in the sump pump reservoir. Cement and wooden 2” x 4” frames were moistened (see Picture 2) or had signs of water damage. Efflorescence (i.e. mineral deposits) and peeling paint was observed on the brickwork of basement interior walls (see Picture 3) and in the boiler room. Efflorescence is a characteristic sign of water intrusion. As moisture penetrates and works its way through mortar around brick it leaves behind these characteristic mineral deposits.

**Moistened 2" X 4" Frame in Basement**

7. Consider replacing the water-damaged 2" x 4"s in the basement. Remove this material in a manner consistent with US EPA recommendations for mold remediation (US EPA, 2001).

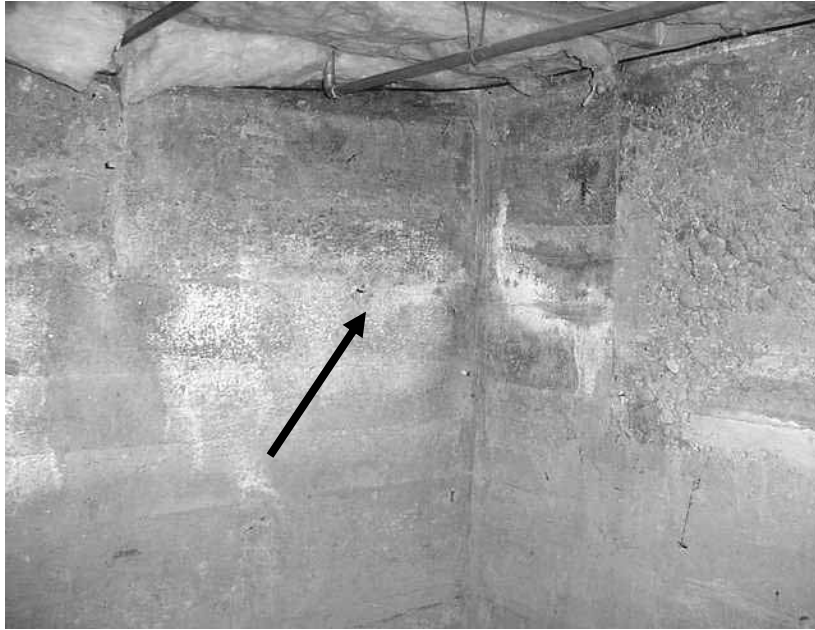
**Picture 3**

**Efflorescence (I.E. Mineral Deposits) Was Observed On the Brickwork on the Interior Walls of the Basement**

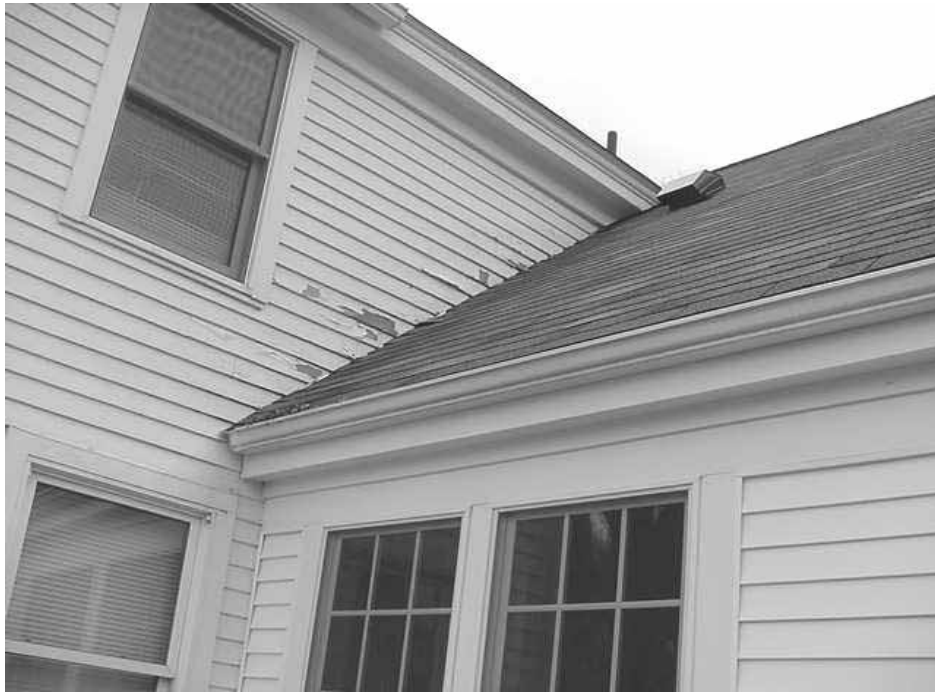
**Picture 4**

Water damage appears to center around a shed-like structure that serves as the exterior entrance into the basement. The roof over this structure forms a joint with the clapboard of the

exterior wall of the 1740 building (see Picture 4). The clapboard at this junction appears to be water damaged. The structure has a peaked roof. It does not appear that the edges of either side of the roof were outfitted with gutters or downspouts. As a result, rainwater runs off the roof onto the ground at the base of the building. Over the years, this runoff has created a trench parallel to the base of the wall, which allows rainwater and melting snow to pool against the foundation. In addition, some downspouts around the foundation empty onto accumulated leaves and mulch (see Picture 5). Leaves and mulch hold moisture in contact with the building's foundation.

**Shed-Like Structure That Serves As the Exterior Entrance into the Basement, Note Lack of Gutter/Downspout System**

6. To prevent moisture penetration into the basement, the following actions should be considered:
  - a) Install gutters on the edge of the roof covering the basement exterior entrance;

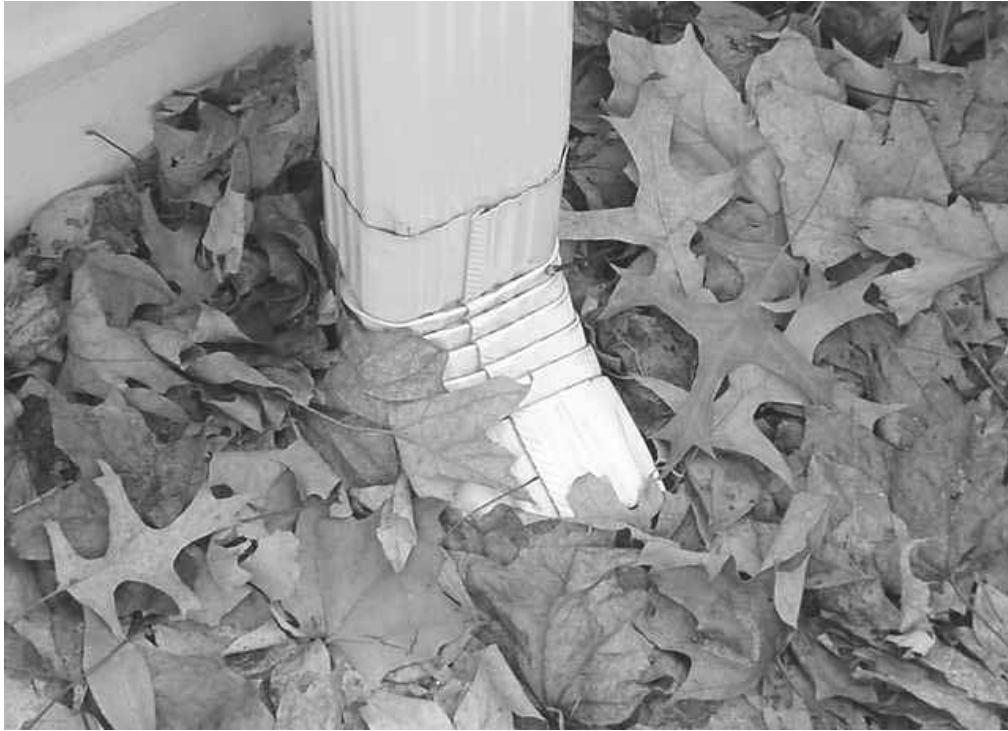
**Picture 5**

**Downspouts around the Foundation Empty onto Accumulated Leaves and Mulch**

- b) Remove mulch from areas near foundation;
  - c) Move foliage to no less than five feet from the foundation;
  - d) Improve the grading of the ground away from the foundation at a rate of 6 inches per every 10 feet (Lstiburek, J. & Brennan, T., 2001);

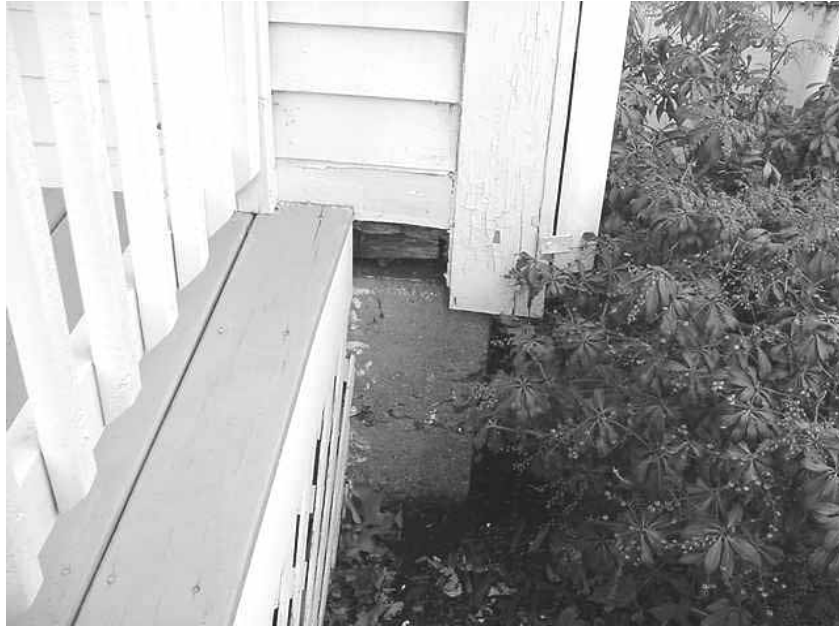
**Picture 6**

Shrubbery exists in close proximity to the foundation walls (see Picture 6). The growth of roots against the exterior walls can bring moisture in contact with wall brick and eventually lead to cracks and/or fissures in the foundation below ground level. Over time, this process can undermine the integrity of the building envelope and provide a means of water entry into the building through capillary action through foundation concrete and masonry (Lstiburek & Brennan, 2001).

**Shrubbery Exists in Close Proximity to the Foundation Walls**

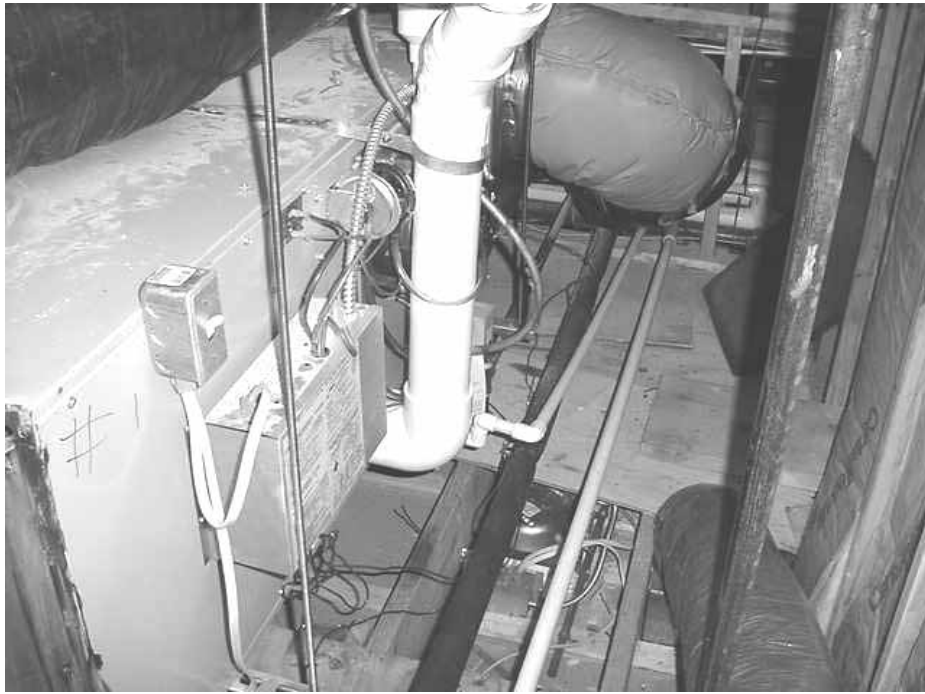
**Picture 7**

**AHU Servicing This General Area Is Located In the Attic Crawlspace**

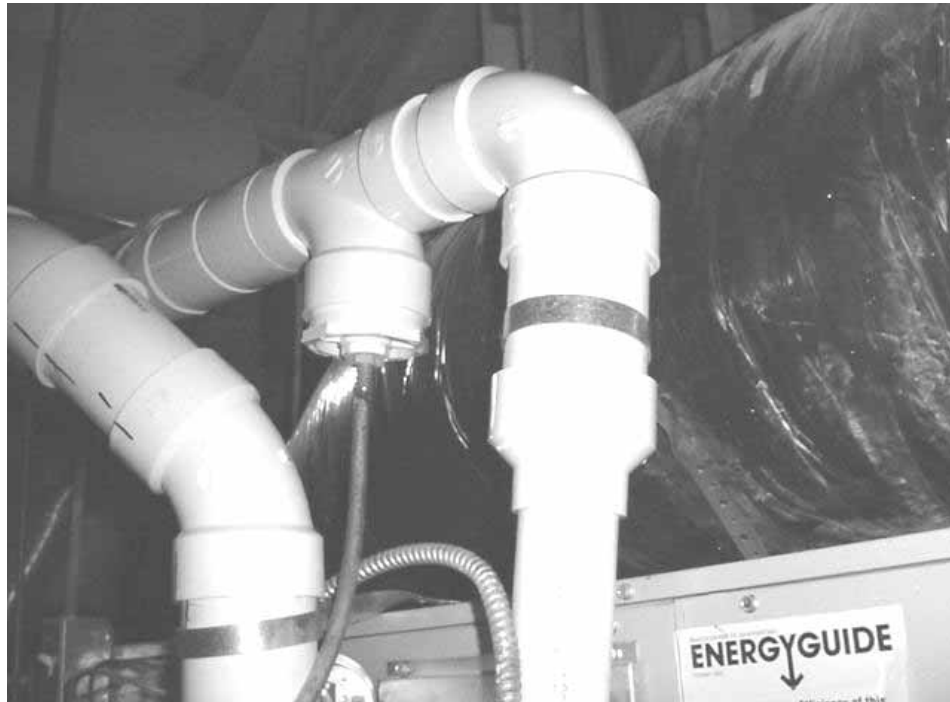
**Picture 8**

As described by Mr. Londa, building occupants report that periodic odors were reported in and around the director's office and restroom hallways after the heating system is activated. Since activating the heating system appears to trigger reports of odor, components of the ventilation system servicing the office and surrounding areas were examined. The AHU servicing this general area is located in the attic crawlspace (see Picture 7). Of note is the configuration of the exhaust vent. The AHU is internally heated with natural gas. The combustion products exit the AHU through a series of horizontal PVC pipes that terminate through the roof (see Picture 8). As natural gas is combusted, products of combustion (carbon

monoxide, carbon dioxide, particulates, etc.) are generated. Another by-product of combustion is water. The horizontal configuration and lack of exterior insulation would make the PVC pipe exhaust vent prone to accumulation of water by condensation, which requires drainage. In an effort to provide such drainage, a “Y” joint was installed in the PVC pipe exhaust vent as a moisture collector (see Picture 9). A plastic hose connects the lowest point of the “Y” joint to the AHU condensation drainage system. The condensation drainpipe is installed in the air handling section on the AHU near the fan (see Picture 10), which can draw products of combustion from the PVC pipe through the condensation drain system. Therefore, the most likely source of the odors reported by Eagle House staff is products of combustion from the AHU. Since the BEHA visit, Mr. Londa further examined this AHU and has found several other possible breaches that could be sources of products of combustion including the joint between the fan/PVC pipe connection and pinprick holes in the heat exchanger.

**The Combustion Products Exit the AHU through A Series of Horizontal PVC Pipes That Terminate through the Roof**

1. Continue with plans to separate the moisture drain from the base of the AHU.
2. Continue with plans to repair breach in exhaust fan/PVC pipe system.
3. Set thermostats to the fan “on” position to operate the ventilation system continuously.

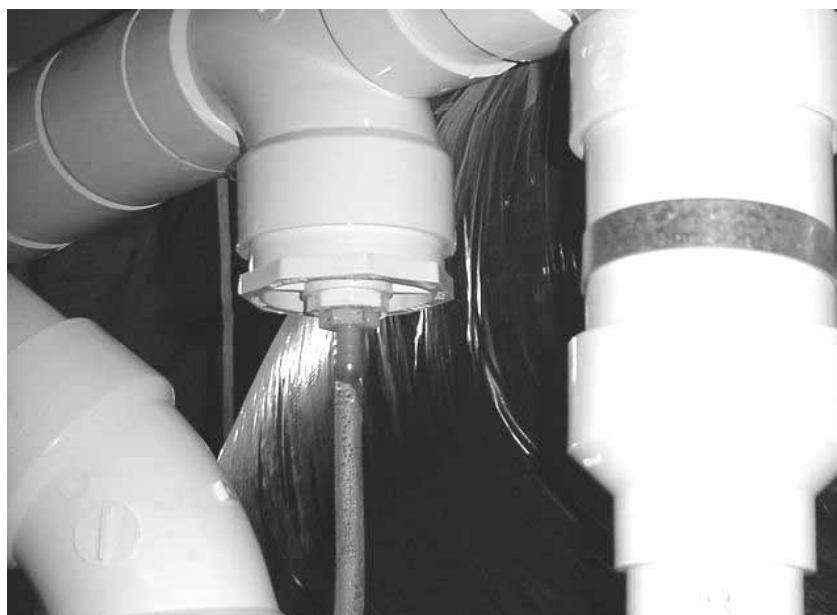
**Picture 9**

**“Y” Joint Was Installed In the PVC Pipe Exhaust Vent as a Moisture Collector**

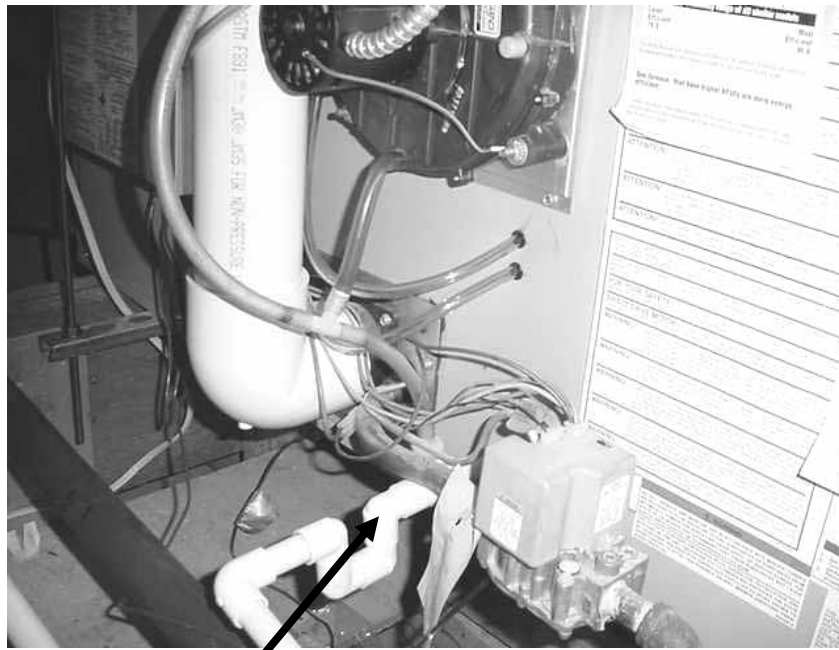
**Picture 10**

**Condensation Drain**

**This Condensation Drainpipe Is Installed Into the Air Handling Section of the AHU**

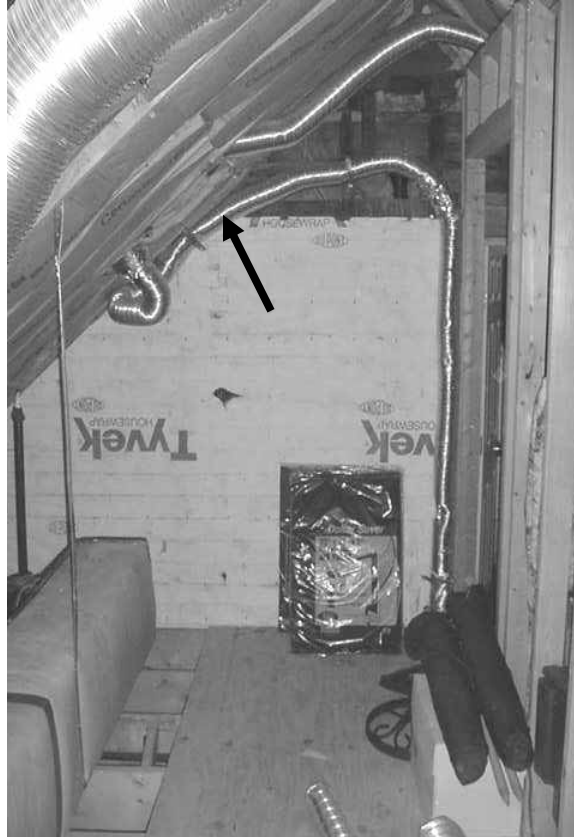
**Picture 11**

Enhancing the accumulation of odors in the eastern section of the new wing is the configuration of the restroom exhaust vents. The hallway outside the restrooms has a fresh air diffuser, which supplies air from the AHU. The restrooms are equipped with ceiling mounted fans, that draw air into a long flexible duct (see Picture 11) connected to a passive (non-motorized) vent in the roof (see Picture 1). Some exhaust ducts have several right-angled bends with at least 12 feet of flexible ductwork between bends. As a rule, each 90° bend in ducting will reduce the draw of air by 50 percent. In this case, the exhaust hose makes roughly three 90° turns (270°). Assuming that the velocity of the draw of air at the metal ductwork at the top of the flexible hose equals 100 percent, the draw of air at the base of the vent is reduced to roughly 12 percent of the draw because of the three 90° bends in the hose. The usual practice employed to make ejection of odors from an interior space is to locate the fan at or near the point of exit in the exterior wall/roof. By locating the fan at the restroom ceiling, the air propelled by the fan

rapidly loses velocity due to the length and number of bends in the flexible ductwork. The degradation of exhaust ventilation efficiency prevents the removal of odors from the restrooms and surrounding areas.

**Restrooms Are Equipped With Ceiling Mounted Fans, Which Expels Air into A Long Flexible Duct**

1. Consideration installing exhaust fans for restrooms at the duct termini at the roof to maximize draw. Examine the feasibility of decreasing the number of bends in flexible ducts.

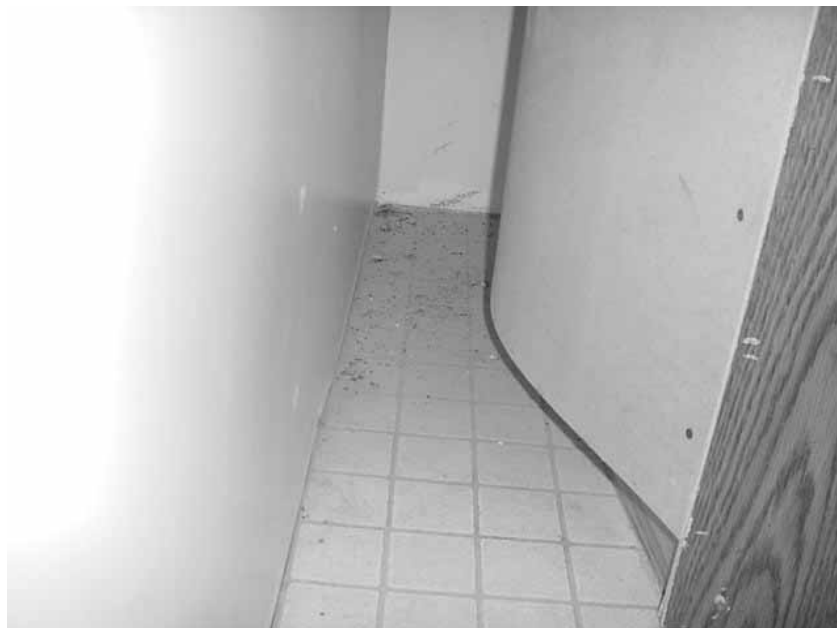
**Picture 12**

The building also shows signs of rodent infestation. Mouse droppings were noted behind the cabinets in the old kitchen (see Picture 12). Rodent infestation can result in indoor air quality related symptoms due to materials in their wastes. Mouse urine is known to contain a protein that is a known sensitizer (US EPA, 1992). A sensitizer is a material that can produce symptoms in exposed individuals (e.g., running nose or skin rashes). A three-step approach is necessary to eliminate rodent infestation:

**Mouse Droppings behind the Cabinets in the Old Kitchen**

10. It is highly recommended that the principles of integrated pest management (IPM) be used to rid the building of pests. A copy of the IPM recommendations can be obtained from the Massachusetts Department of Food and Agriculture (MDFA) at the following website: [http://www.state.ma.us/dfa/pesticides/publications/IPM\\_kit\\_for\\_bldg\\_mgrs.pdf](http://www.state.ma.us/dfa/pesticides/publications/IPM_kit_for_bldg_mgrs.pdf).  
Activities that can be used to eliminate pest infestation may include the following:
